THE WENDOVER ARM TRUST WORKING PARTY NEWS

ISSUE 88

December 2011

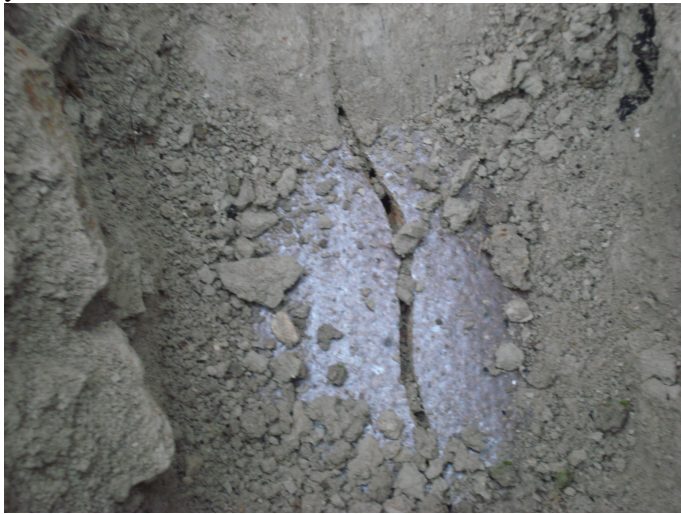
In April 2005 trial trenches were dug at the 100 metre markers to determine the position and depth of the 18" earthenware pipe carrying the water from Wendover under the canal bed. At that time several of the exposed pipes had longitudinal cracks along the crown of the pipe. Although the pipe generally runs on the offside of the canal, a year or two back an unknown manhole was found at the foot of the towpath bank at chainage 3622. We knew that at chainages 3500 and 3600 the pipe was on the offside at these points so it was decided to dig additional trial trenches to determine the exact route of the pipe in this area. To pipe cap where the pipe crosses the bed of the canal means cutting off access to the Drayton Beauchamp end and has to be carefully timed.

This investigation was successfully completed and it demonstrated the deterioration in the pipe after 100 years as shown below:

TYPICAL LONGITUDINAL CRACK IN THE 18" PIPE

The state of the pipe also explains why BW gave the Trust £200,000 towards restoration of the canal back to normal water level in lieu of the essential maintenance cost of renewing the pipeline.

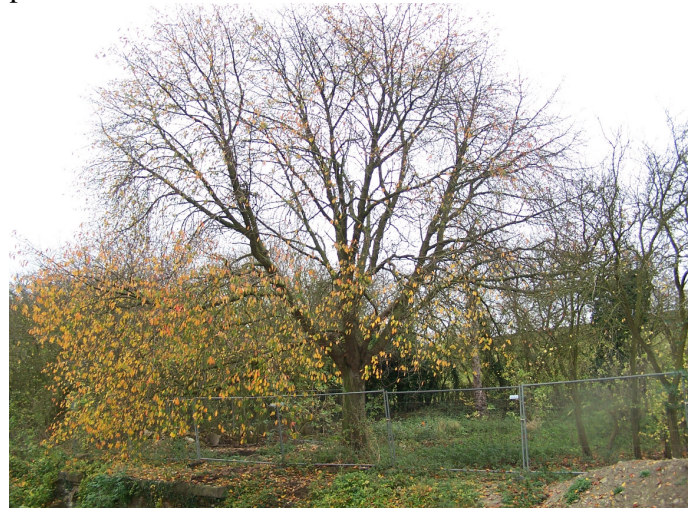
In examining the site BW expressed concern over the roots of the prunus tree that dominates the site at present.

THE PRUNUS TREE AT WHITEHOUSES

The pipe from the present manhole on the 18" pipeline to the pumping shaft lies between the prunus tree and the settling tank. Substantial roots from the tree are already intruding into the settling tank.

In case it becomes essential to remove the tree, something we hope will not happen yet, Margaret Leishman has taken some hardwood cuttings in the hope that these will take and enable us to replace the tree in a more suitable location with an original off-shoot in the future. As a member of the RHS, Margaret has since contacted their members' advisory service and they say that the only easy way to get a true replica of the original is to take a hardwood cutting during the winter, and has sent her detailed instructions. Margaret is going to take further cuttings based on this advice.
